## STRENGTHENING OF IMPACT-DAMAGED BRIDGE GIRDER USING FRP LAMINATES

**A. Nanni, P. C. Huang, and J. G. Tumialan**  
Center for Infrastructure Engineering Studies  
University of Missouri – Rolla  
Rolla, MO 65409, USA

The exterior prestressed concrete (PC) girder of Bridge A10062, located at the interchange of Interstates 44 and 270 in St. Louis County, Missouri, USA, was impact-damaged by an overheight truck. Removal of the loose concrete showed that two prestressing tendons were fractured due to the impact. This resulted in approximately 10% reduction in flexural moment capacity. There has been limited research on the repair of PC bridge girders damaged by vehicular impact. Due to the repetitive nature of highway loading, repair methods such as internal strand splices and external post-tensioning were found to be questionable because they could not restore the ultimate strength to the damaged member. In this case study, it was decided to use carbon FRP (CFRP) laminates to restore the original structural capacity of the girder. It was demonstrated CFRP bonded reinforcement could be an effective repair technique in terms of installation as well as design. If the present trend in

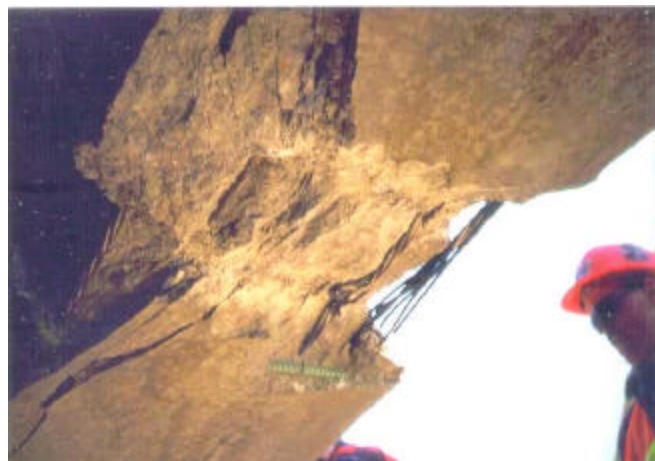
Bridge A10062 is located at the interchange of the Interstates 44 and 270 in St. Louis County, Missouri, USA. With a relatively low roadway clearance of 4.47 m, it was impact-damaged by an overheight truck in one of its exterior prestressed concrete (PC) girders. Removal of the loose concrete showed that two prestressing tendons were fractured due to the impact (see Figure 1).

**Figure 1. Fractured Tendons after the Removal of the Damaged Concrete**

The rehabilitation of this impact-damaged girder called for concrete repair and application of CFRP laminates. The flexural strengthening consisted of two 45.7cm wide plies with lengths of 285 and 325 cm, respectively, applied to the bottom of the girder with fibers aligned along its longitudinal axis. The double ply-laminate was centered over the damaged area (see Figure 3). Sixteen strips, 10.2 cm wide and spaced at 20.4 cm on centers, were then U-wrapped around the bulb of the girder over the previous installation (see Figure 4). The purpose of the U-wrap is to prevent the delamination of the FRP plies applied to the bottom surface of the girder. After repair, the factored capacity of the girder was computed to be  $fM_{n( repaired )} = 3,035$  kN-m, which is 7 % larger than the original capacity.

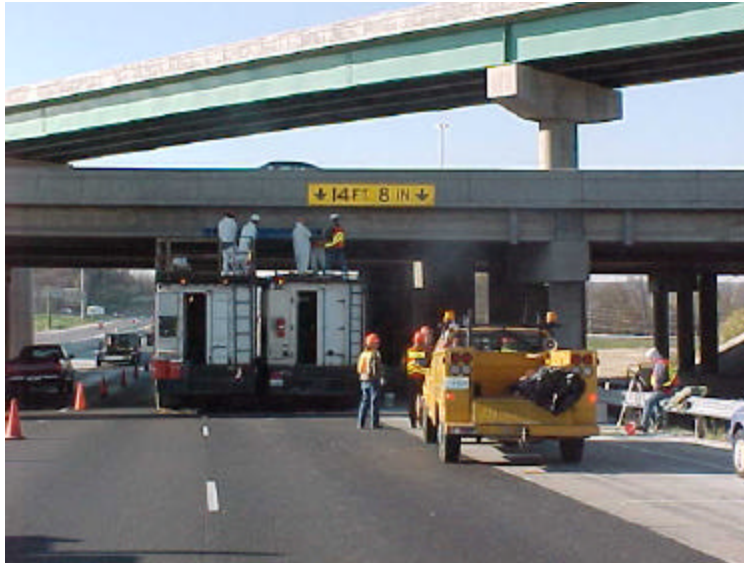
Figure 5 shows the Missouri DOT crew at work. The installation of the FRP including surface preparation as described was performed in one morning.

**Figure 5. Installation Crew at Work**
