SHEAR STRENGTHENING OF URM CLAY WALLS WITH FRP SYSTEMS

S. Grando*, M.R. Valluzzi*, C. Modena*, J.G. Tumialan**

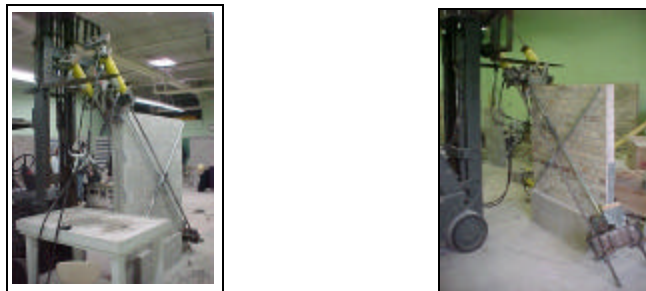
Figure 4. Test Setups

The specimens were tested in a closed loop fashion. Two 30-ton-capacity hydraulic jacks, activated by a manual pump, were used to generate the load along the diagonal of the wall being tested. When loading, the force was applied to the wall by steel shoes placed at the top corner, and transmitted to similar devices at the bottom corner through high strength steel rods. Figure 4 shows the test setup. To collect displacements and the crack opening in the walls, two Linear Variable Differential Transducers (LVDTs) were placed the diagonals on each side of the walls.

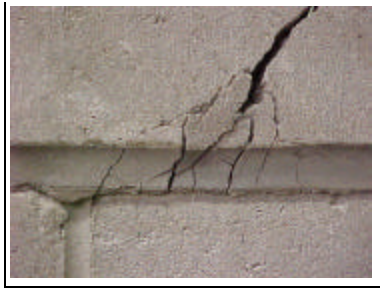
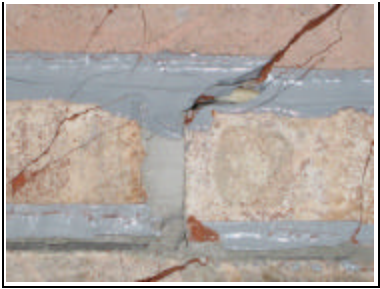
Figure 11. Crack Behaviour in one side (left) and two-sides (right) reinforcement

In these strengthened walls, the presence of the reinforcement forced the formation of diagonal cracks running through the masonry units (Figure 11) and not with the stair shape behaviour: the crack, usually, develops over the embedding material and the FRP system, without changing the path and continuing its opening over the joint. Thus, the tensile forces in the FRP bridging the diagonal crack increased the shear capacity of the

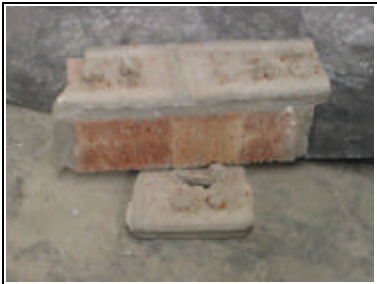
Figure 14. Dowel action effect

The good behaviour of the clay panels, in comparison with the similar concrete walls, is due to the fact that the mortar can get inside the holes of the bricks and create a solid system (see Figure 14). This becomes like a dowel action effect of the mortar and increases the capacity of the wall itself. The splitting failure (Figure 11), obtained in the central zone along the compressed diagonal in wall CB2, was due to a great tangential strain, resulting from the high bond between the clay bricks and from the symmetric reinforcement (#2 GFRP bars both sides). The splitting failure (Figure 12), obtained in the upper corner along the compressed diagonal in wall WI2 is probably due to an incorrect test setup. The sliding failure (Figure 15) obtained in wall CL2 was due to the combination between the increase of the ultimate load (thanks to the presence of the reinforcement over both sides) and the lower strength in an unreinforced joint of mortar. However, in this case, a larger increase in shear capacity was recorded, thanks to the fact that the horizontal laminates engaged the masonry layers where the sliding occurred, and the cracks running along the head joints were bridged.
