## STRENGTHENING OF IMPACT-DAMAGED BRIDGE GIRDER USING FRP LAMINATES

**A. Nanni, P. C. Huang, and J. G. Tumialan**  
Center for Infrastructure Engineering Studies  
University of Missouri – Rolla  
Rolla, MO 65409, USA

The exterior prestressed concrete (PC) girder of Bridge A10062, located at the interchange of Interstates 44 and 270 in St. Louis County, Missouri, USA, was impact-damaged by an overheight truck. Removal of the loose concrete showed that two prestressing tendons were fractured due to the impact. This resulted in approximately 10% reduction in flexural moment capacity. There has been limited research on the repair of PC bridge girders damaged by vehicular impact. Due to the repetitive nature of highway loading, repair methods such as internal strand splices and external post-tensioning were found to be questionable because they could not restore the ultimate strength to the damaged member. In this case study, it was decided to use carbon FRP (CFRP) laminates to restore the original structural capacity of the girder. It was demonstrated CFRP bonded reinforcement could be an effective repair technique in terms of installation as well as design. If the present trend in

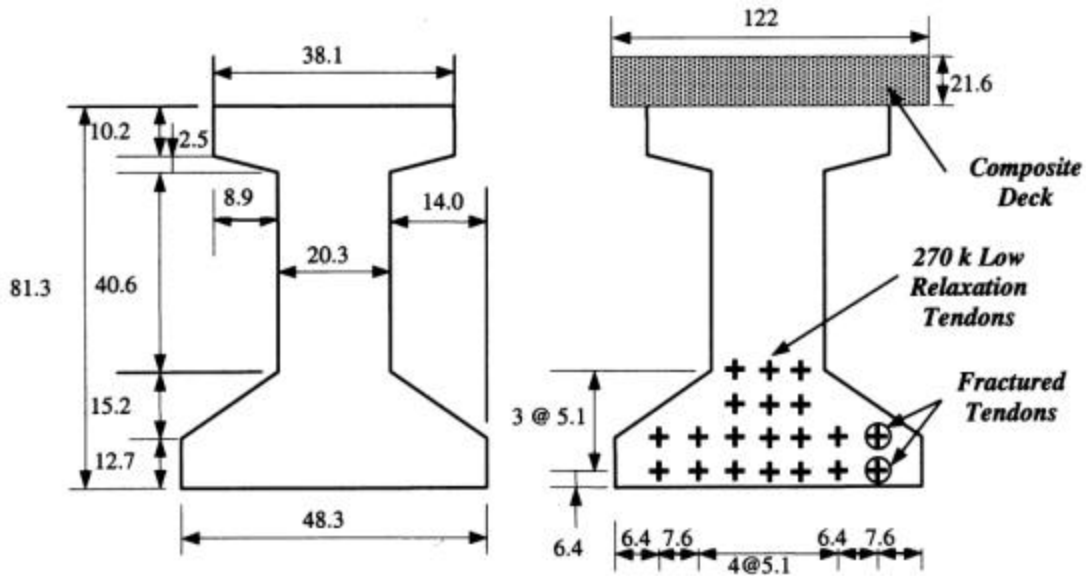
The damaged girder was prestressed by 20 low-relaxation 7-wire steel strands with a tensile strength of 1862 MPa. The cross section of the damaged girder and prestressing details are shown in Figure 2. Material properties used in the analysis are shown in Table 1. It was assumed that a portion of the bridge deck with dimensions of 21.6 × 122 cm provided composite action with the girder as shown in Figure 2.

Figure 2. Girder Dimensions and Prestressing Details (dimensions in cm)
