RINFORZO DI EDIFICI STORICI IN MURATURA UTILIZZANDO MATERIALI COMPOSITI E POLIUREA

PRESERVATION OF HISTORICAL MASONRY BUILDINGS USING GFRP COMBINED WITH SPRAYED POLYUREA

Renato Parretti⁽¹⁾ **Antonio Nanni**⁽¹⁾ **Andrea Prota**⁽¹⁾

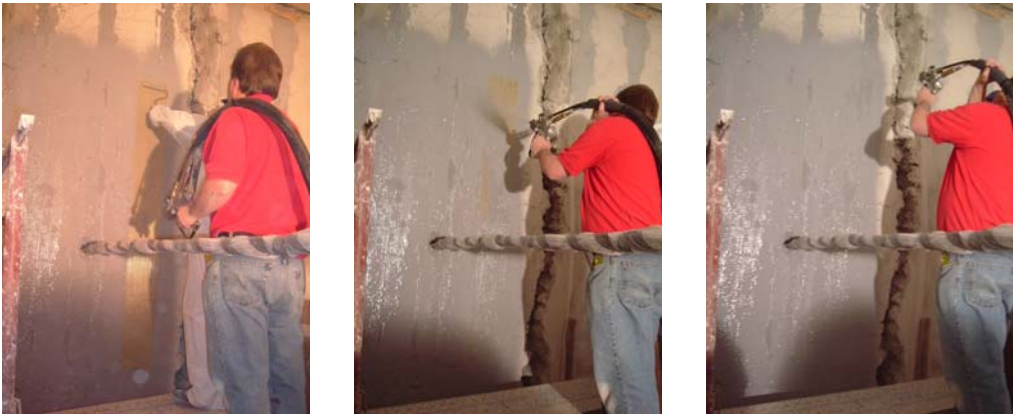
Figure 2 - Pictures of the Strengthening Phase

The installation of the external GFRP reinforcement was easy and simplified with respect to the wet lay-up technique normally used to apply traditional FRP. The main advantages of the proposed technique are related to the fact that the primer is not needed and the im-

pregnation of the reinforcement is performed by spraying the Polyurea with no need for touching the surface (Figure 2).

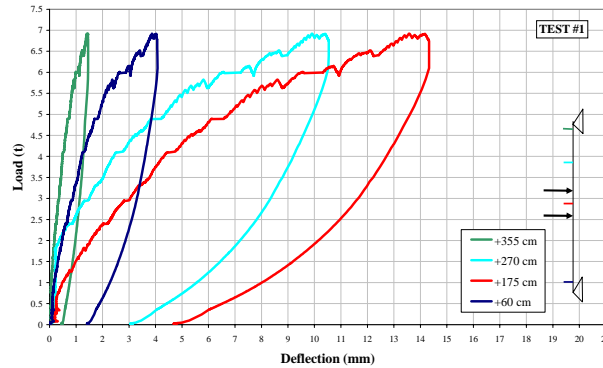
Figure 9 - Load Deflection Diagram (Test #1)

Test #1 was performed on Panel A without any reinforcement. Location of the four LVDTs listed in Table 2 is also reported in Figure 9 where the envelope curves obtained by plotting applied load vs. horizontal displacement of the panel are shown. As expected, the two LVDTs closer to mid-span of the panel recorded the maximum displacement approximately equal to 15 mm. The non-symmetrical behavior of the panel is evident as a larger deflection was recorded on the bottom half.

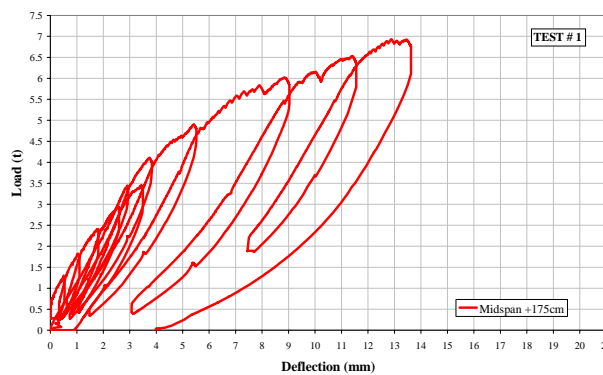
Figure 10 - Loading-Unloading Cycles (Test #1)

The test was performed by applying the load in cycles up to predetermined levels, in order to avoid any anomalies in the behavior of the tested panel. An example of such loading-unloading procedure is reported in Figure 10 relatively to the displacement at mid-span. The test was terminated when the deflection displayed a flat pattern with no further increase of the applied load. At this point we were approaching the member's ultimate capacity; however, it is unclear whether the rupture was initiated by failure of the masonry or by shear failure of the top and bottom portions of the panel. A theoretical analysis shows that the nominal flexural capacity of the panel when the rupture is initiated by failure of the masonry would have been equal to $M_n=61$ kNm, assuming a tensile strength of the masonry equal to 1/3 of its compression strength, f'_m . The experimental moment recorded for this test was equal to $M_{exp}=64$ kNm. Therefore, it is reasonable to assume that the member's rupture was due to failure of the masonry. A masonry failure for this type of structure is the result of the arching effect. At this point, it was clear that the addition of external reinforcement would not necessarily increase the capacity of the panel, but could have important effects on the panel stiffness and stability.

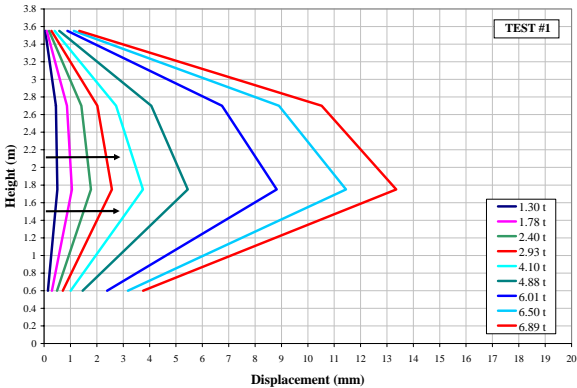
Figure 11 - Horizontal Displacement as a Function of the Wall Height (Test #1)

Figure 11 reports the deformed shape of the panel, for different load steps, with reference to the room floor level rather than the starting point of the tested panel. As the load increases, the displacement recorded increases proportionally; the maximum value is recorded at mid-span of the panel. This demonstrates that the predominant deformation is caused by flex-

ural stresses, although shear deformations may not be disregarded as it is shown by the horizontal deformation recorded at 0.6 m elevation.

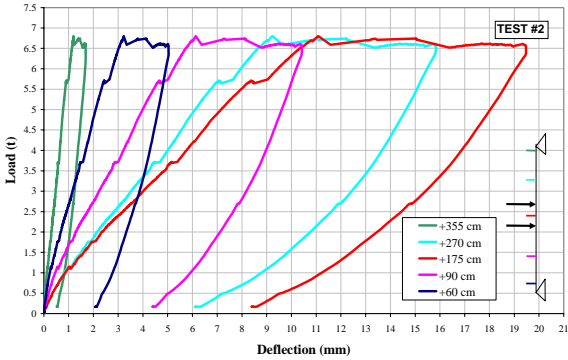
Figure 12 - Load Deflection Diagram (Test #2)

The second test (Test #2) was conducted on Panel A once the first test was terminated and the panel had been strengthened with one layer of GFRP grid 80 cm wide over the entire height. The same instrumentation was used to monitor also this panel with the addition of another LVDT placed at one fourth of the height of the panel as reported in Table 2 and in Figure 12 showing the load-deflection envelopes. The results obtained from this second test show the attainment of the same maximum capacity of the previous test with a maximum recorded displacement of about 20 mm. Also this test was conducted by applying the load in cycles.

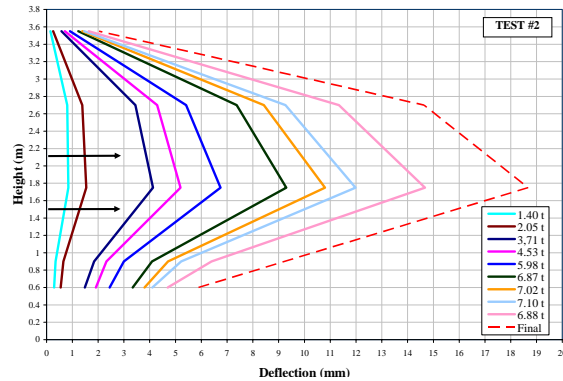
Figure 13 - Horizontal Displacement as a Function of the wall Height (Test #2)

Figure 13 shows the deformed shape of the panel at different heights starting from the floor level, for increasing applied loads. The dashed line represents the final deformation registered after Test #2 considering that the panel presented a residual permanent deflection. The residual displacements measured at the end of Test #1 at heights of 600, 1750, 2700 and 3550 mm are equal to 1.2, 4.0, 3.3 and 0.4 mm, respectively, as indicated in Figure 11.

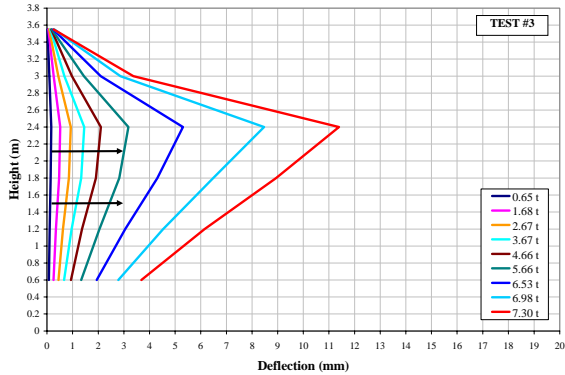
Figure 15 - Horizontal Displacement as a Function of the Wall Height (Test #2)

The third and last test (Test #3) was performed on Panel B strengthened with three layers of GFRP grid 80 cm wide and extended for the entire height of the panel. Two more LVDTs were added to monitor the panel deflection at the locations reported in Table 2 and Figure 14 showing the load-deflection envelopes. The maximum recorded displacement was 14 mm, measured at 2.4 m from the floor. Figure 15 shows the deformed shape of the panel as a function of the applied load. Also in this instance, the test was terminated when the deflection displayed a flat pattern with no further increase of the applied load. A theoretical analysis indicates a nominal flexural capacity for FRP rupture failure mode equal to $M_n=106.5$ kNm [5], much larger than the experimental recorded moment. This behavior could lead to the conclusion that the full flexural capacity is not achievable because shear failure of the panel is initiated in the top and bottom portions of the tested specimen. It is most likely the bottom portion of the wall to show major signs of distress as depicted in Figure 15 where a displacement of almost 4 mm was recorded.

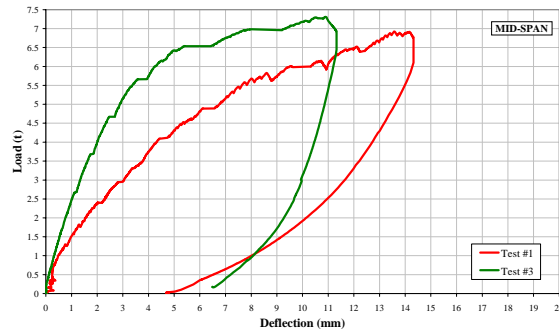
Figure 17 - Mid-span Deflection for Test #1 and #3

Figure 17 reports the load-displacement plots at mid span for Test #1 and #3. As expected, the application of three layers of GFRP reinforcement (Test #3) results in increased stiffness in the linear-elastic cracked region of the load deflection behavior. Also, the GFRP strengthening allows for an increase of 10% of the wall capacity with respect to the virgin panel even in the presence of arching effect.

The maximum displacement recorded in Test #3, about 11 mm, is smaller than the one recorded for the un-strengthened panel equal to 14 mm. However, rather than the displacement, it is of interest to emphasize the way the tested panel reaches its ultimate capacity. While the un-strengthened panel reached failure with a gradual stiffness deterioration, for the specimen strengthened with FRP there is a clear change in stiffness at about 5 mm of horizontal displacement (Figure 17). It is at this point that the shear failure of the two ends starts to occur.
